Във връзка с проблеми възникващи при монтажа на облегалката на стола за кола модел-Navigator, както и последвалите при нас рекламации и извършените тестове на модела искаме да ви уведомим следното :

In connection with installation problems of the backrest of car seat models Navigator and Explorer and a like, the received claims for this rising problem and made tests of these models , we want to inform you for the following :

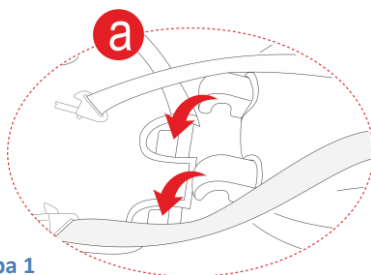
фигура 1

**1.** Монтажа на гърба на този стол се извършва на хоризонтална повърхност, като монтажните „куки“ на гърба се вкарват в ушите на седалката.

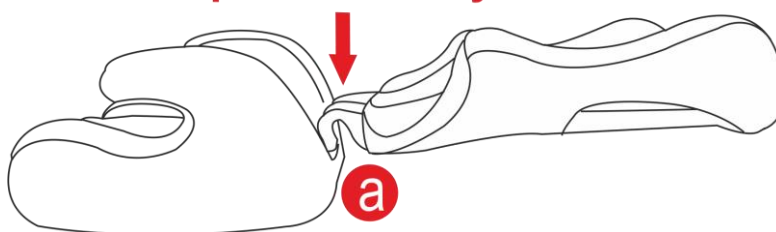
фигура 2

**2.** С две ръце и по рязко усилие долната част на гърба/до куките/ се притиска надолу така че да се чуе изщракване , признак че двата елемента са закопчани, чак след което горната част на гърба може да се повдигне до необходимото му позициониране.

**Притиснете тук!**

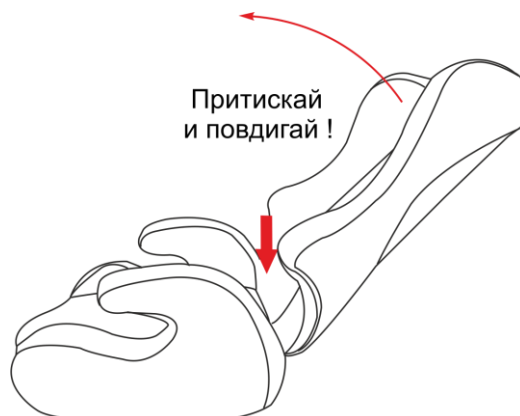
**3.** При всяко изравняване на седалката и гърба и следващо изправяне на облегалката следва да се проверява дали някоя от „куките“ не излязла частично от седалката, което при изправяне на гърба я деформира непоправимо. Затова преди всяко изправяне на облегалката от хоризонтално положение следва с ръка поставена в близост до „куките“ да се притисне отново а с другата да се изправя.

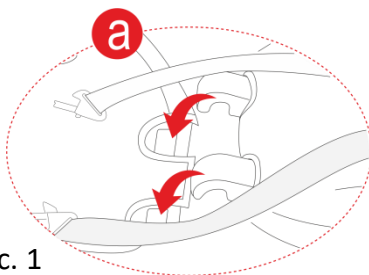
Pic. 1

1. The mounting (assembling) of the backrest on this models of car seats must be done ONLY on flat horizontal surface and the “ mounting HOOKS ” of the backrest must be inserted into the openings of the seat !

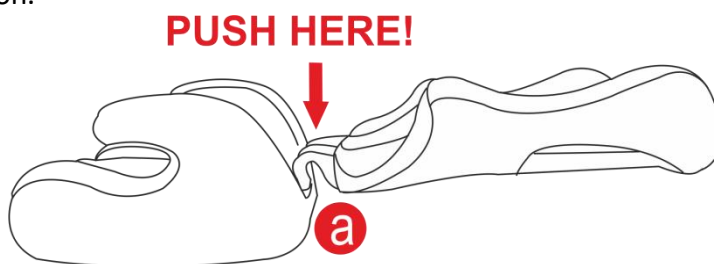
Pic. 2

2. With both hands and by sharply effort at the bottom of the backrest / near to the hooks/ press down , so that to hear a “Clic” sound, which is a sign that the both elements are fastened. ONLY after that , the upper part of the backrest can be lifted till the needed position.

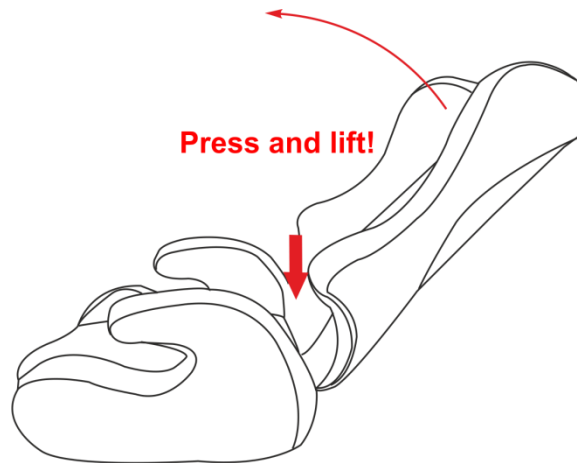
3. At each alignment of the seat and backrest and next straightening of the backrest, obligatory should be checked whether the "hooks" are in correct position! If some of them are partially goes out from the opening of the seat and the customer straighten up the backrest, then the hook of the backrest will be broken or deformed irreparable.

Because of this before each straightening of the backrest from horizontal position , the customer should press again with one hand over the “hooks” and with other hand to lift the backrest .
